Pressurised pipes: explosions

The Incidents

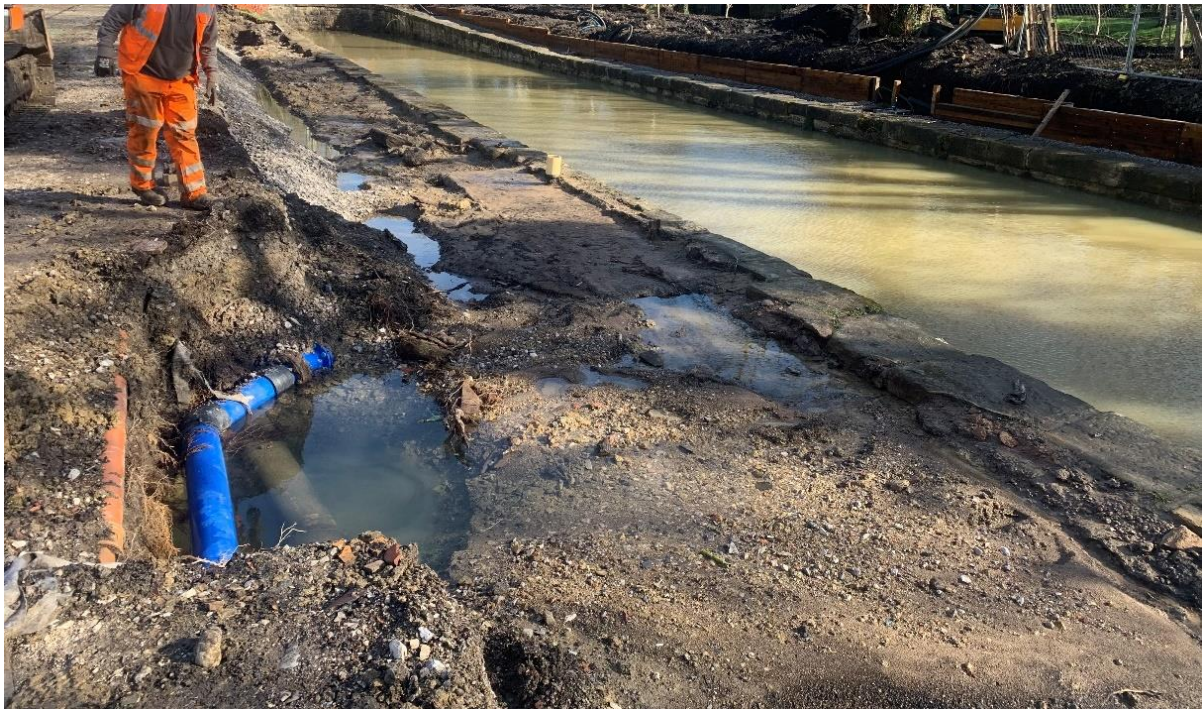
Later that week the pipe, backfilled and unexposed, did explode, fortunately, over the weekend when no one was on site. The force of the explosion excavated a large hole around and under the pipe (Figure 1), stripping away the clay and spreading sand for c.10m. The actual explosion spread gravel c. 2 – 3m.

It did explode during a cold snap, which might be the reason for its failure. However, it is possible that the changes in backfill may have caused differential ground settlement and increased stress on the pipe, which could have caused the explosion too.

Figure 1: Results of the explosion with several square metres of soil blown out exposing the pipes.

- Be careful when backfilling around these pipes, it could cause additional stress on the pipes which can cause them to fail.

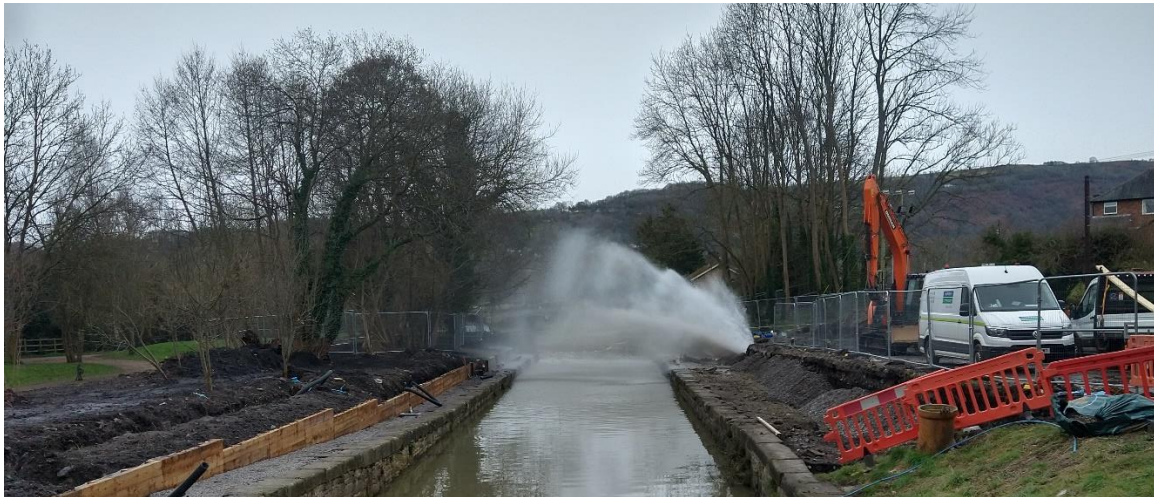
The following weekend, again fortunately when workers were offsite, the second water main exploded (Figure 2). The water company had inspected this pipe after the first explosion and said that it was fine. The cause of these failures are still being investigated.

Figure 2: The second water main bursting and spraying water.
